## AERZEN USA: IMPROVING RELIABILITY IN THE OPERATION OF AN AIR SEPARATION PLANT CASE STUDY

Process	Air separation plant supplying oxygen to a glass furnace at a lighting products company
Problem	Experiencing significant reliability problems and excessive maintenance costs keeping the existing supplier's feed and vacuum blowers operational.
Solution	Installed an Aerzen model GLa19.19Az 2 lobe blower in the most problematic application in the plant – the feed (pressure) blower
Results	Blower completed 28 months of operation, without any downtime.

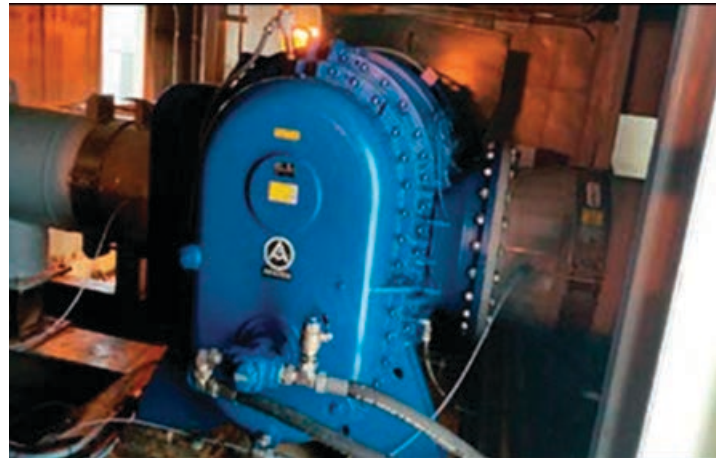
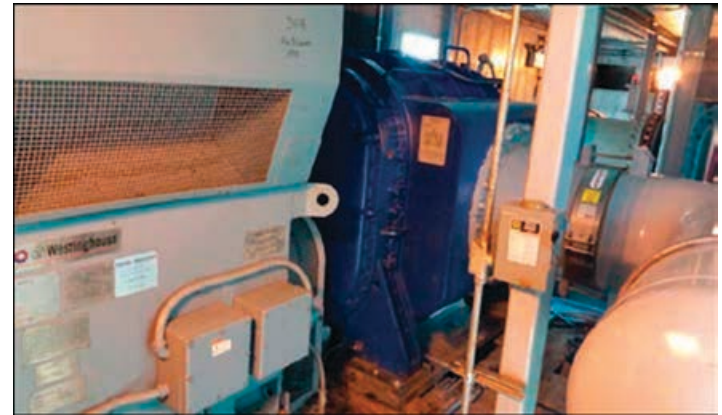
Aerzen proposed to their customer install an Aerzen model GLa19.19Az 2 lobe blower in the most problematic application in the plant – the feed (pressure) blower.

This blower would typically be operating at 8 psi pressure differential and the inlet volume flow is 18,683 ICFM. The customer purchased a blower and it was installed and operational in July 2015.
